9th Avenue East Class Environmental Assessment

SCHEDULE B REPORT

City of Owen Sound

Tatham Engineering Limited

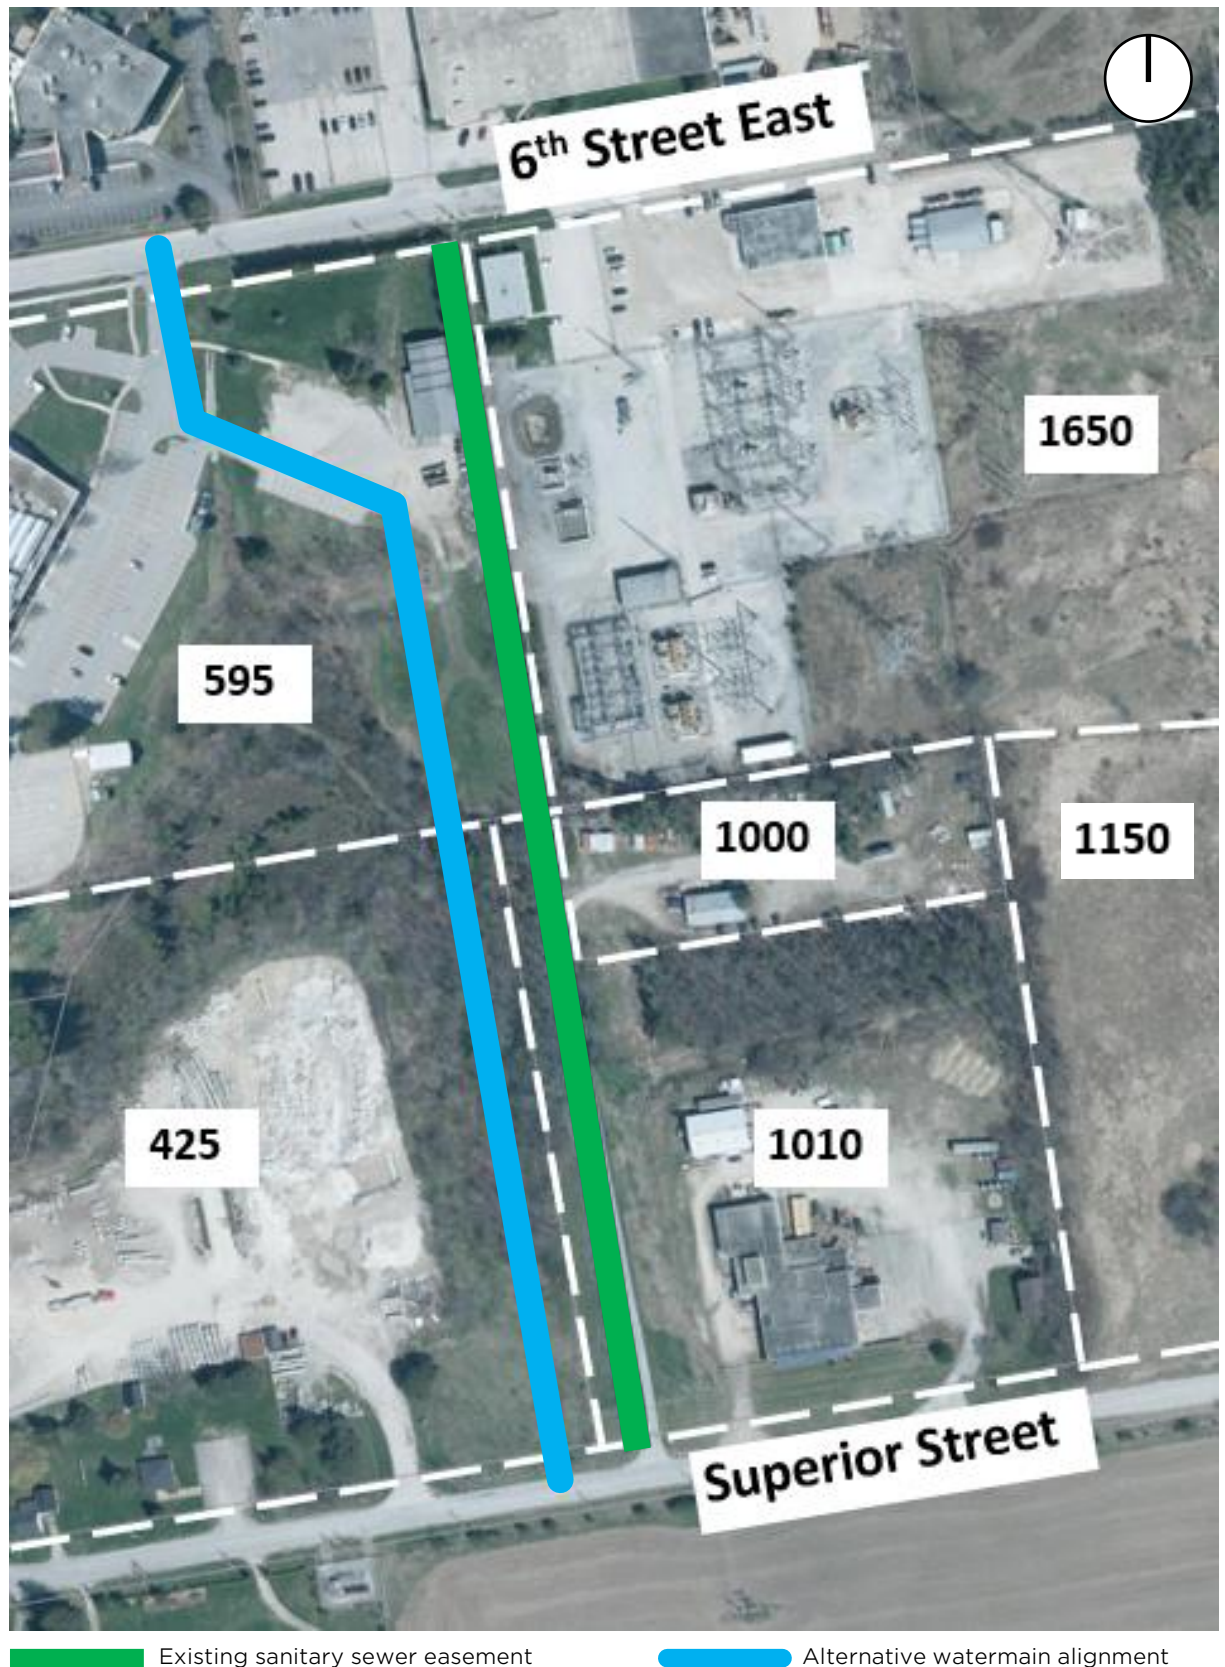
Figure 3: Looping Watermain from Superior Street to 6th Street East

Existing sanitary sewer easement

Alternative watermain alignment

In consideration of the discussion above, the looping watermain from Superior Street to 6th Street East was assumed to be “established, extended or enlarged” outside of a road allowance or utility corridor (as identified in Figure 3), and as such, a Schedule B Class EA was initiated to review and select an appropriate alignment. Five alternative solutions were explored, in addition to a “do nothing” scenario, as detailed in Table 1 and illustrated in Figure 4 through Figure 8.

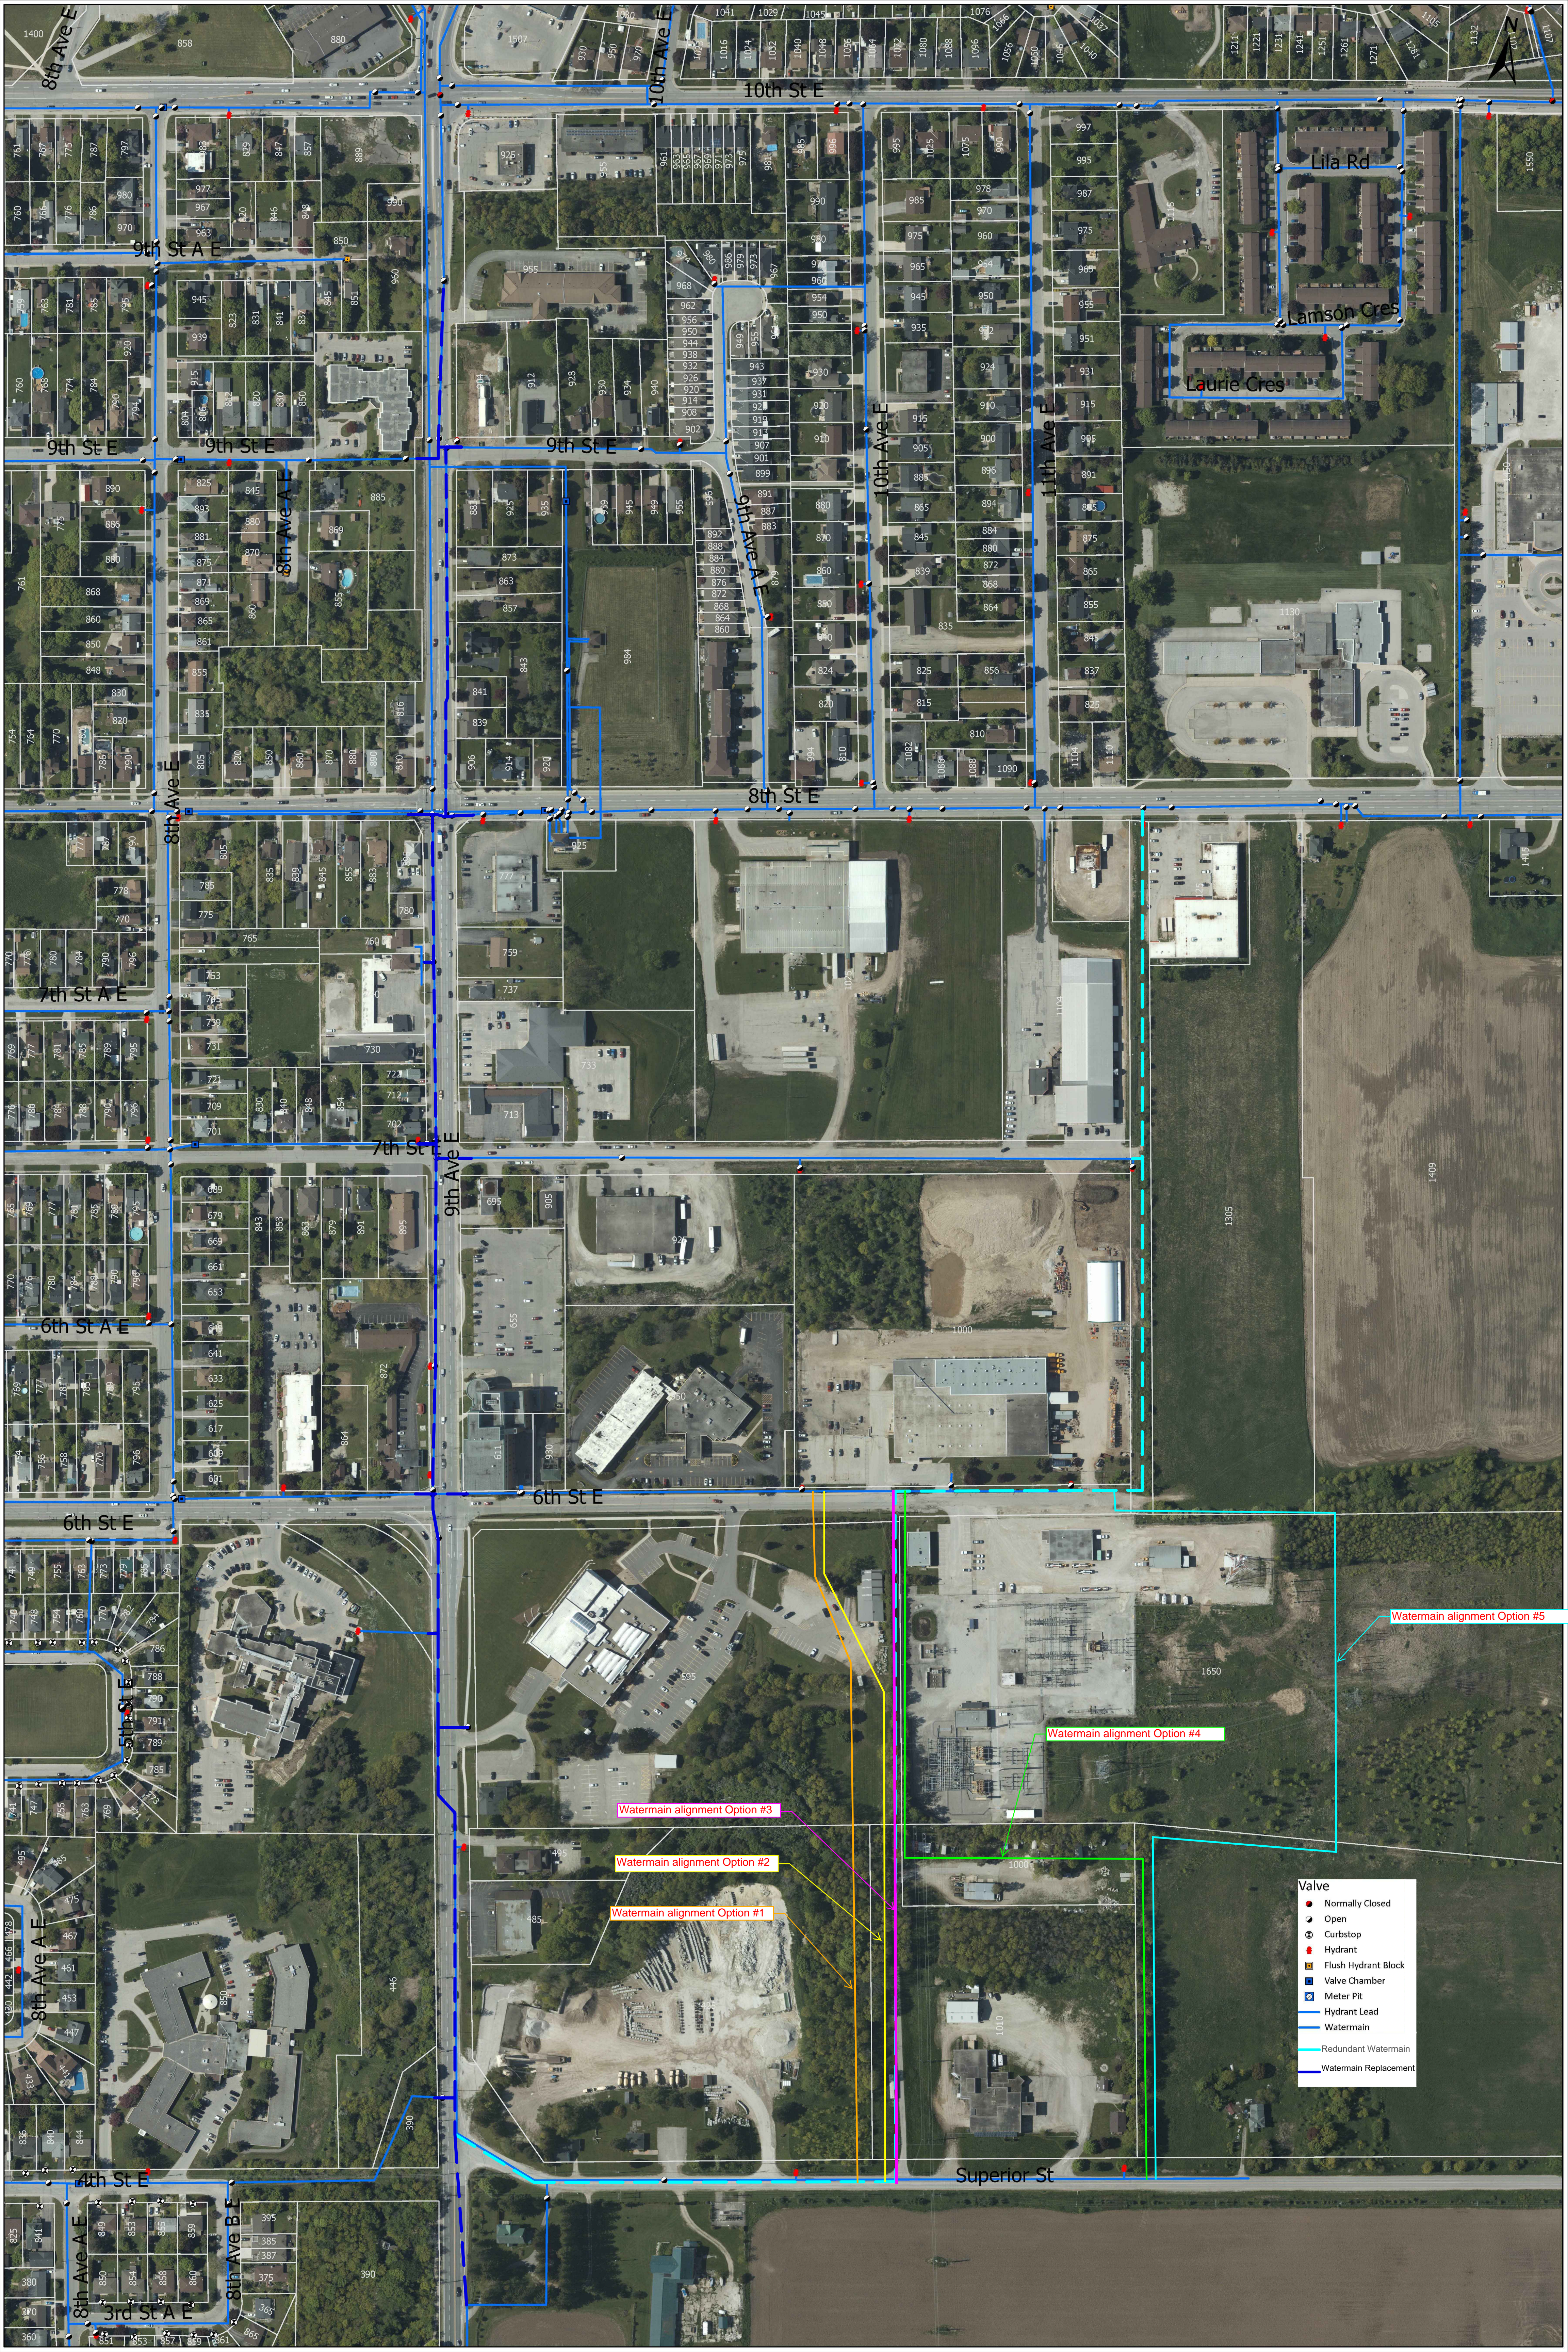
PROJECT	9th Ave E Watermain Replacement and Road Rehabilitation	FILE	121387
		DATE	June 30, 2022
SUBJECT	WaterCAD Results - Pressure	NAME	EP
		PAGE	1 OF 4

WaterCad Flows

Water Demands			
Development	Description	Node ID	No. of Units	ppu	Pop.	ADD (L/s)	ADD (m ³ /day)	MDD (L/s)	MDD (m ³ /day)
1409 8th Street East	Residential	J-888	721	2.3	1658	7.68	663.32	14.59	1260.31

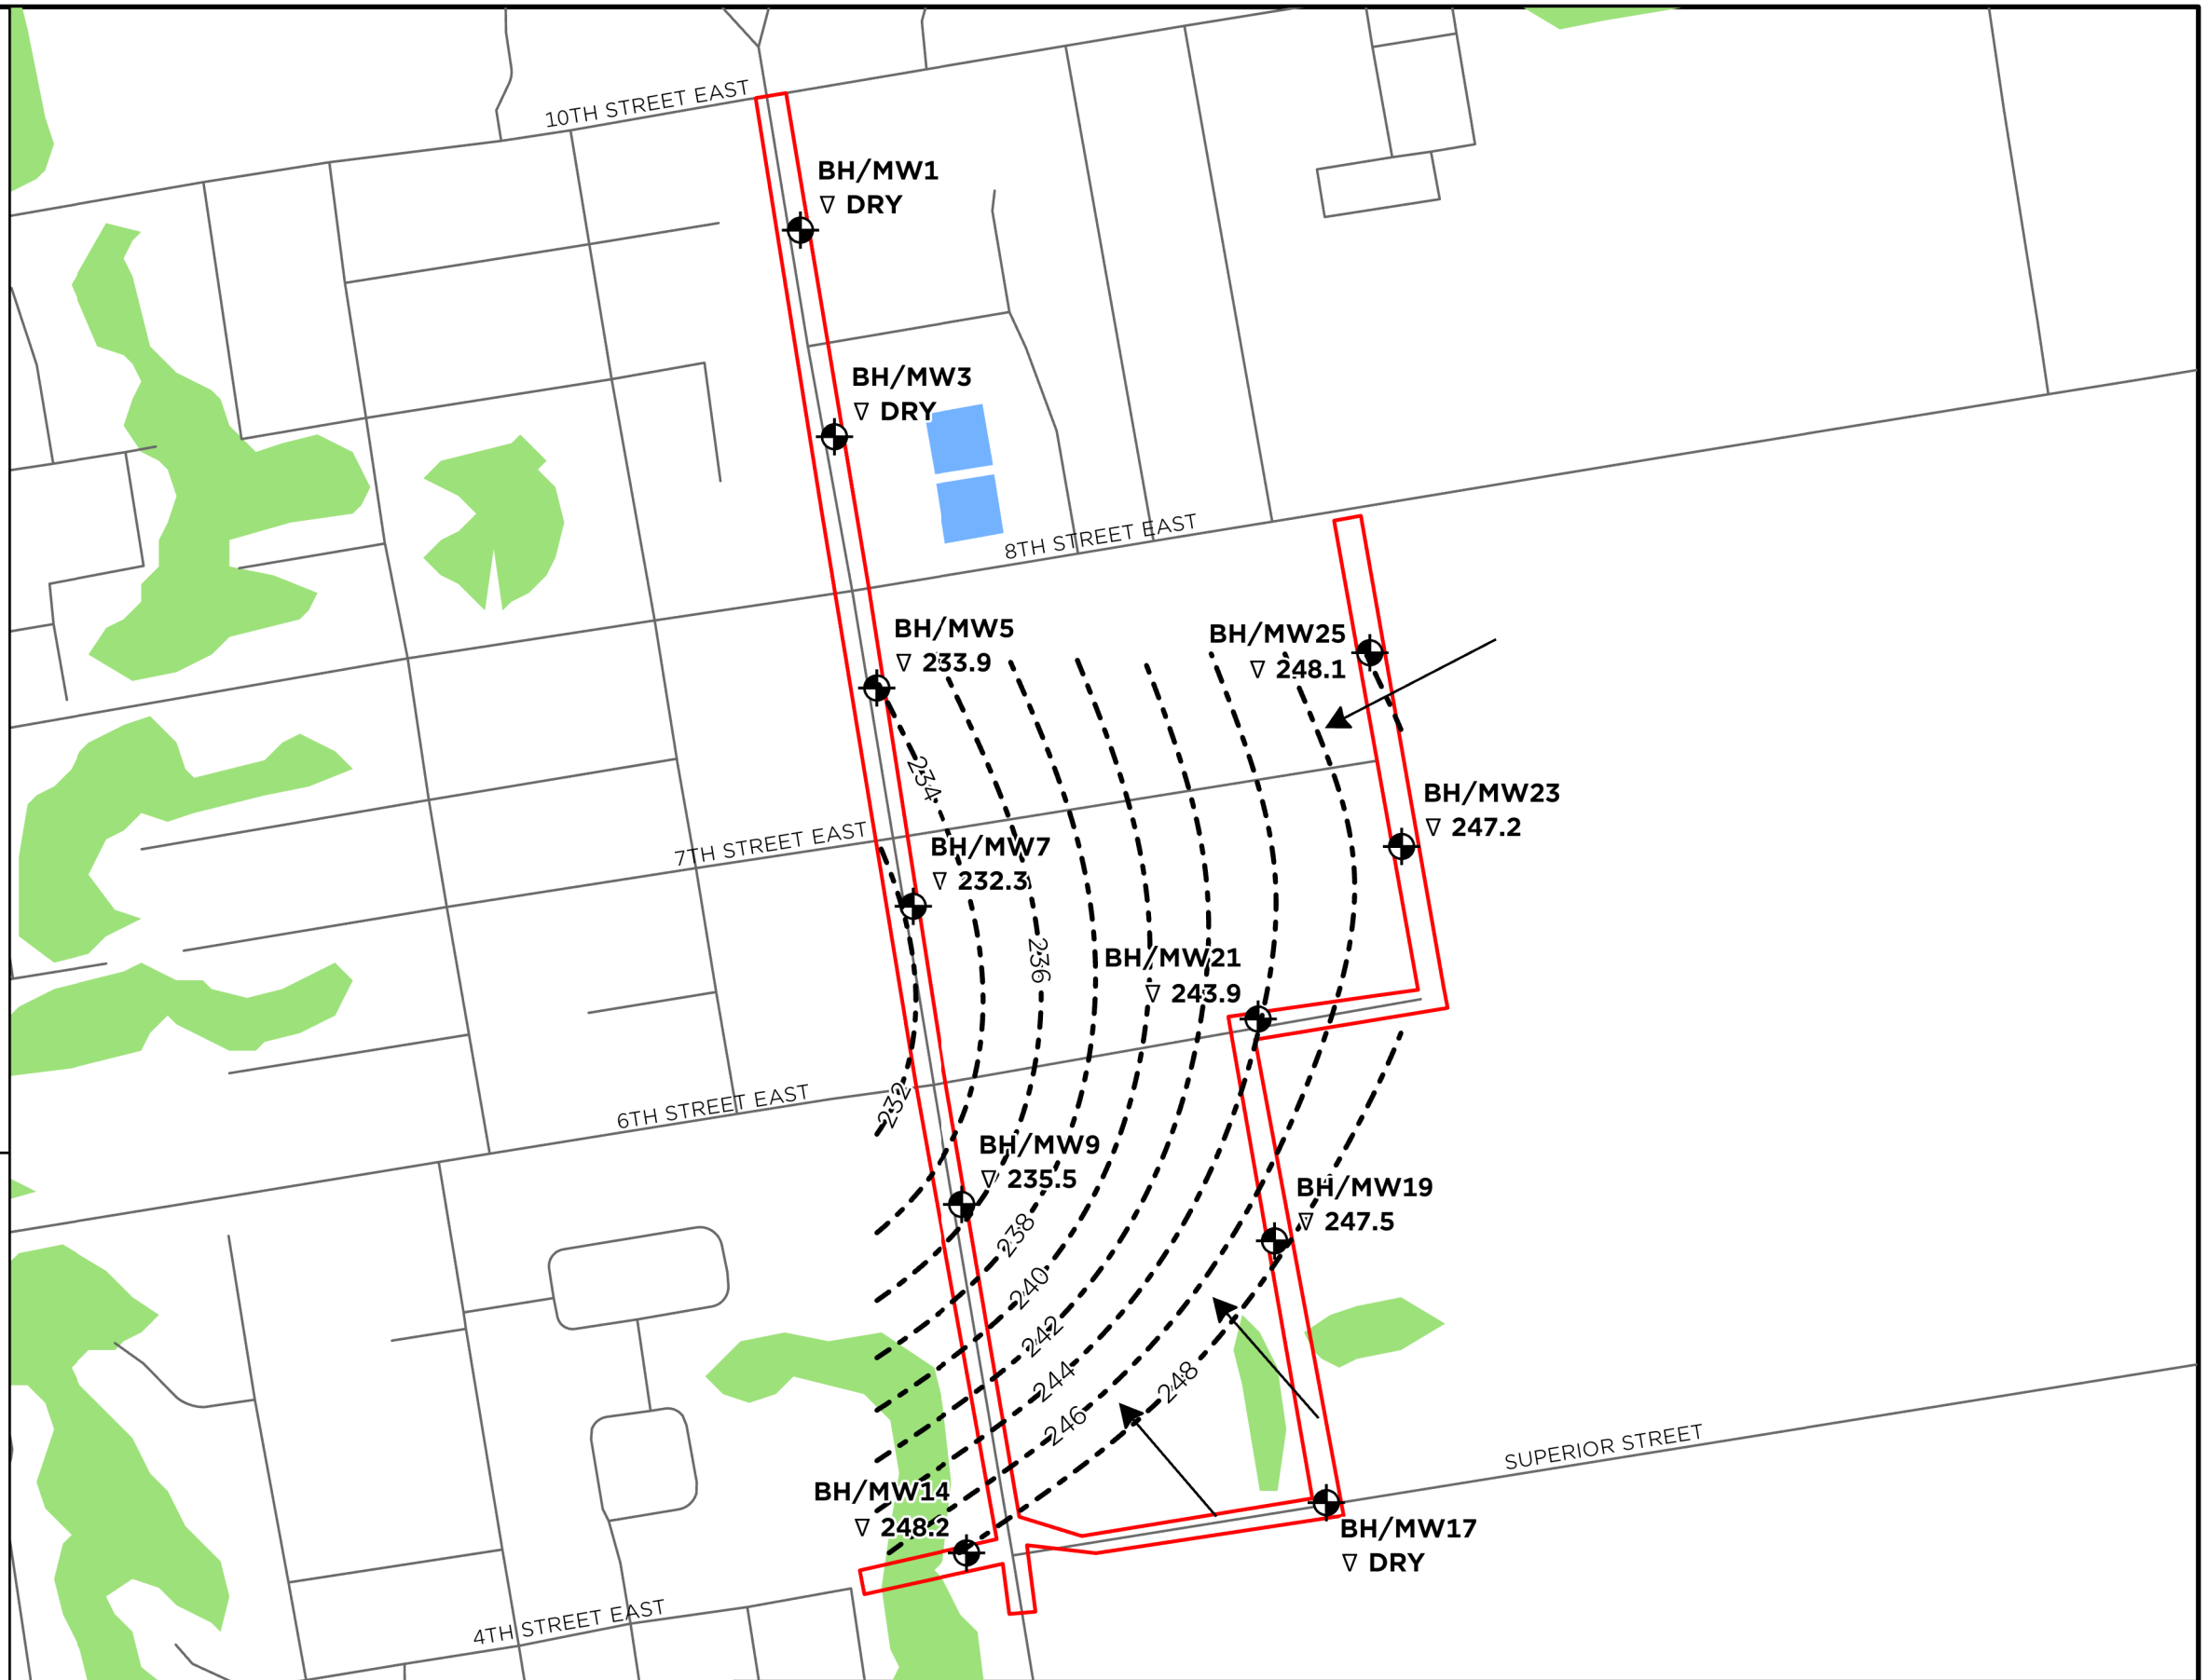
FIG-8

-   SITE
-   MONITORING WELL, 2023
-   GROUNDWATER CONTOURS -
FEB, 2023
-   WOODED AREA
-   WATERBODY
-   WATERCOURSE
-   ROAD

Stabilized groundwater levels on February 13, 2023 ranged from 0.1 to 3.2 m below exiting grade (elevation 232.2 to 248.2 m asl). Local groundwater flow is anticipated to flow to the northwest/west towards Georgian Bay and/or Sydenham River as shown on Figure 8.

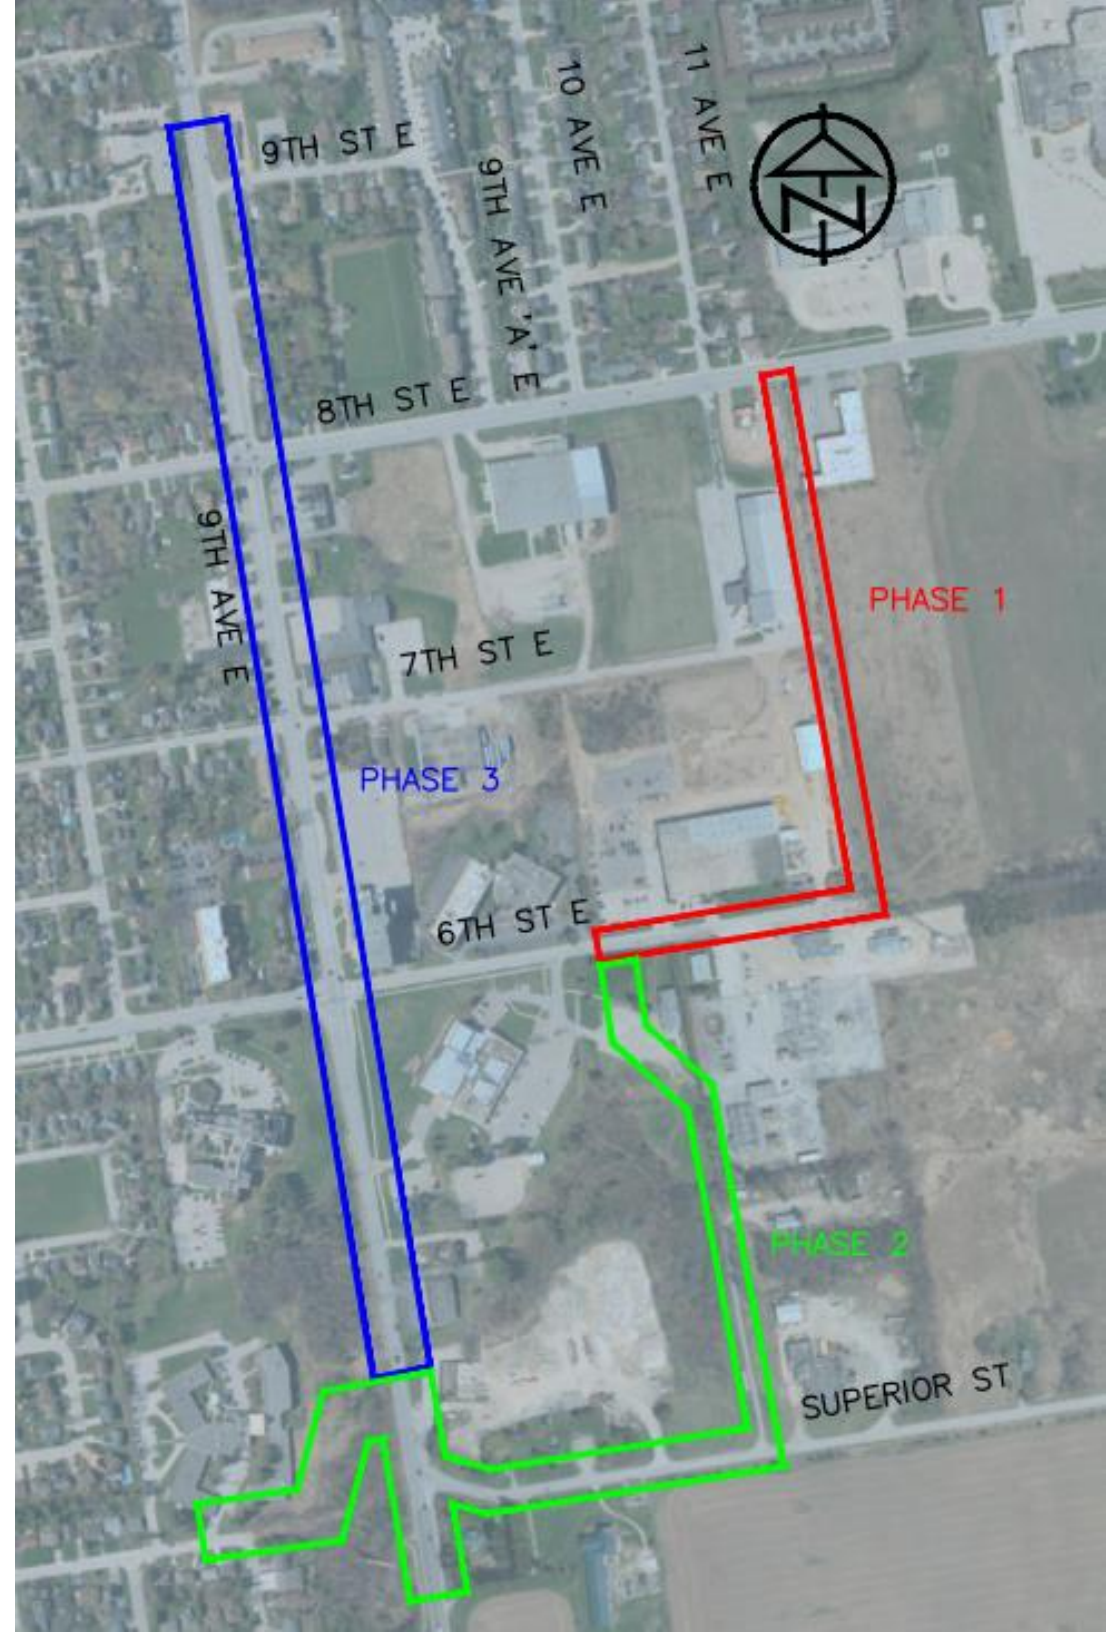
- REPLACE deteriorated watermain on 6th Street East
 - from dead end
 - to future south looping watermain connection
 - length: 200 metres

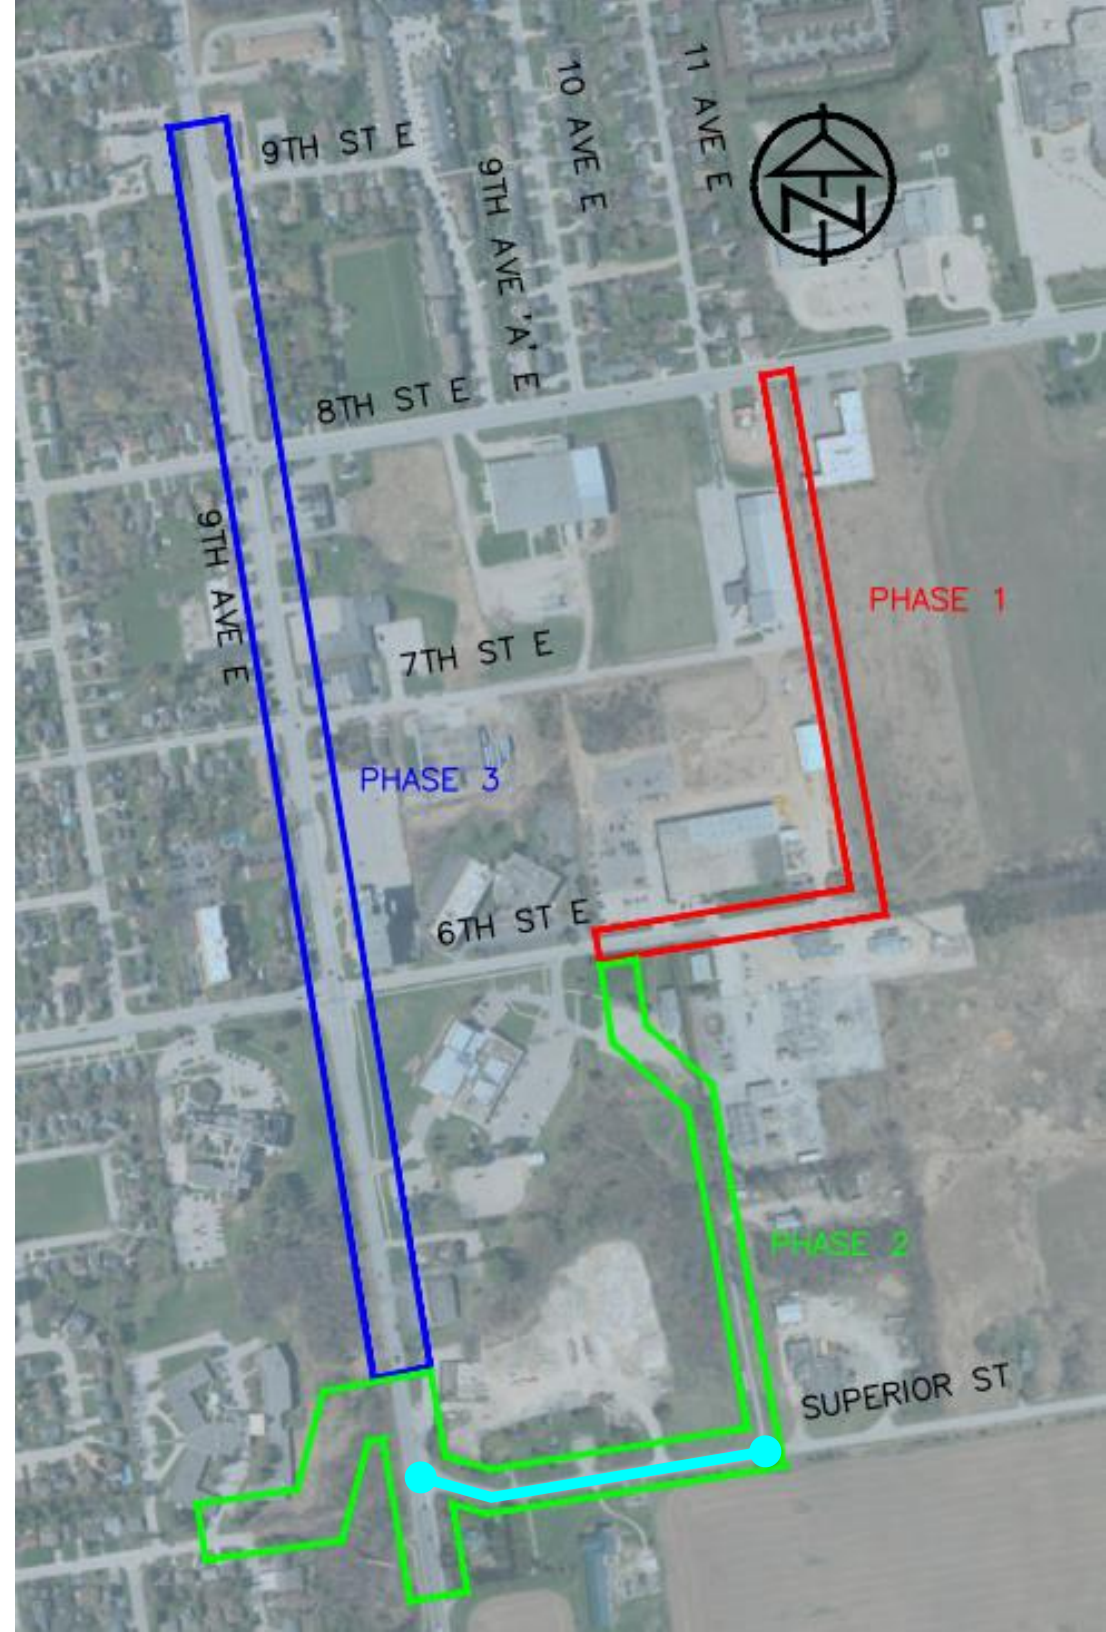
- REPLACE and UPSIZE watermain on Superior Street
 - from dead end
 - to 9th Avenue East
 - length: 280 metres

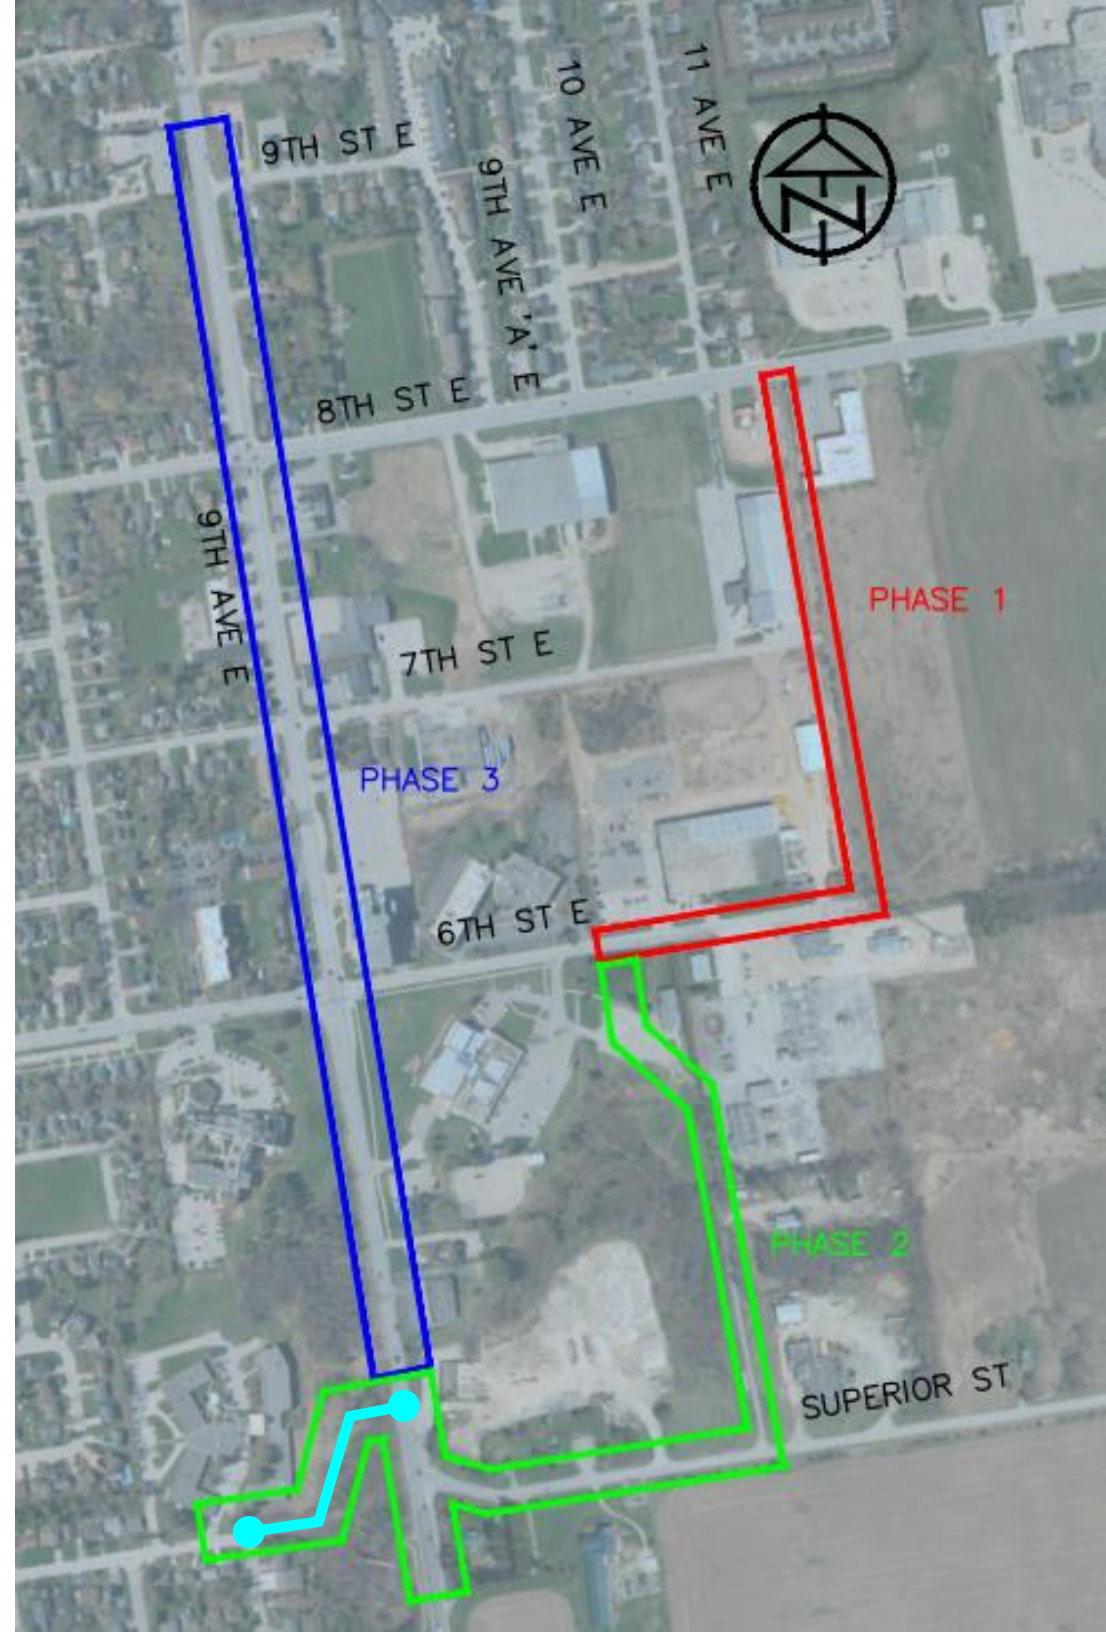
- REPLACE and UPSIZE watermain
 - from 9th Avenue East
 - to 8th Avenue 'B' East/4th Street East
 - length: 160 metres

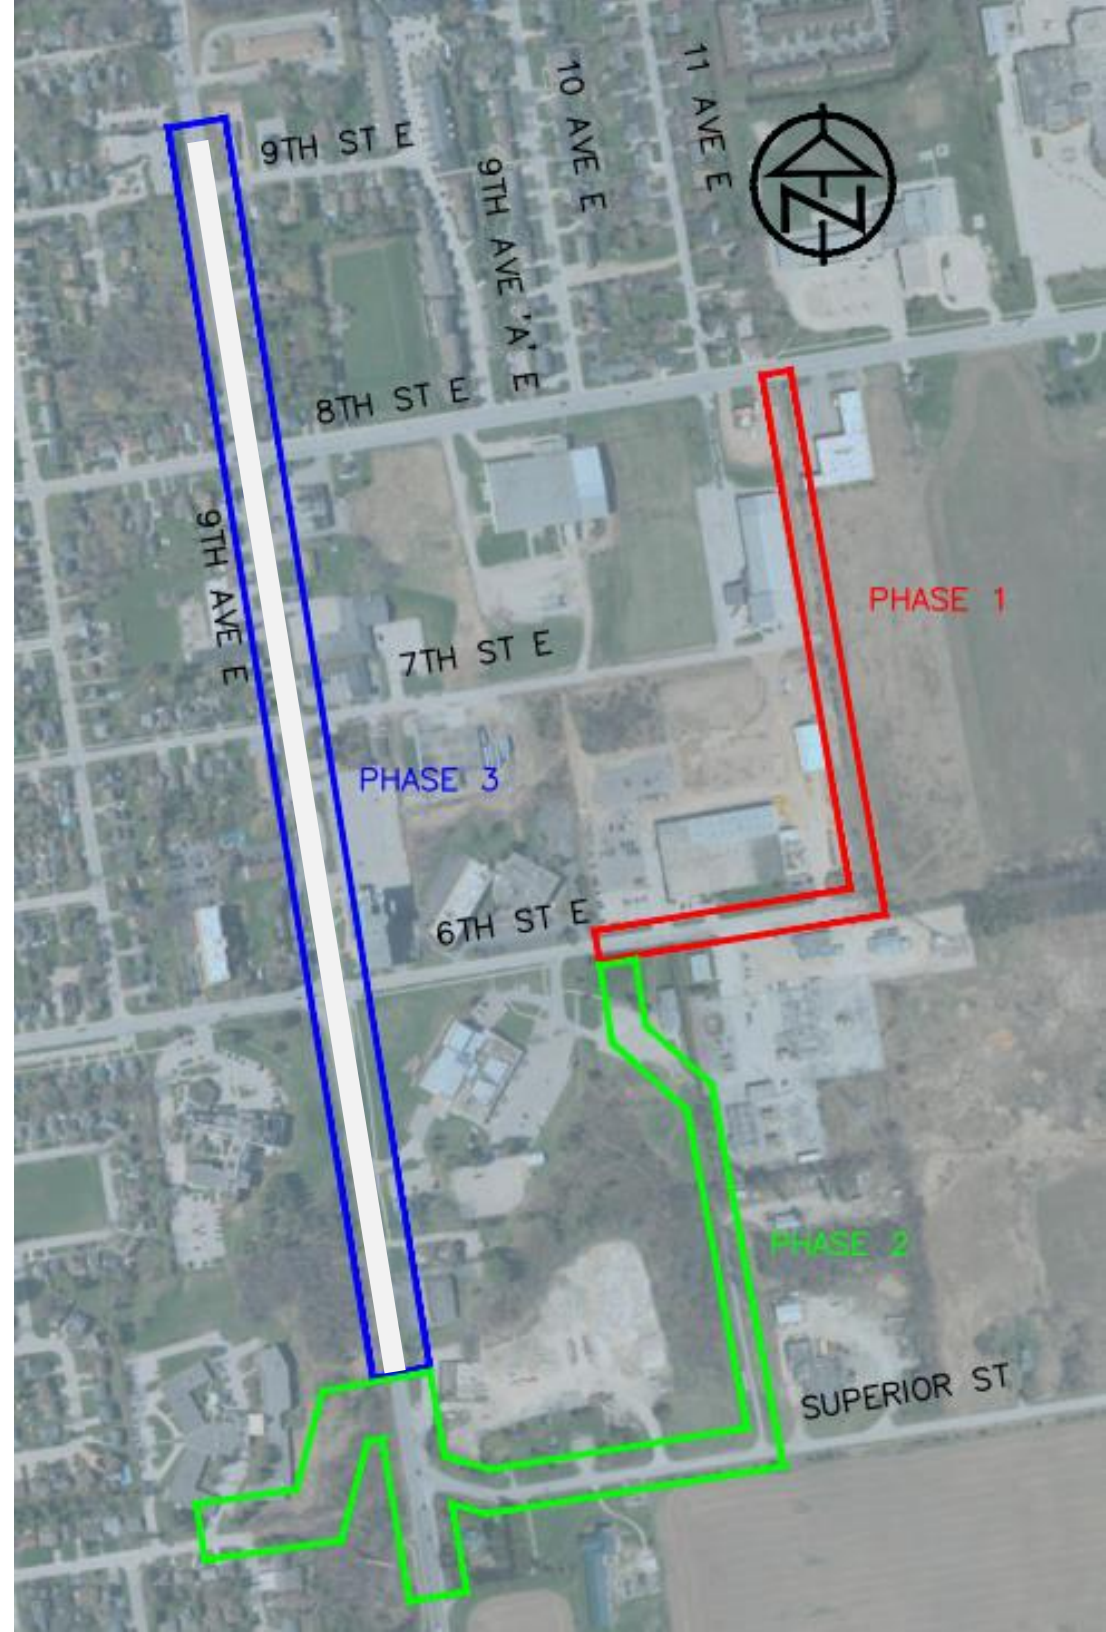
- REPLACE road asphalt
- REPLACE guiderail
- REPLACE sidewalk (localized areas only)
